SPACE SHUTTLE AGING ELASTOMERS

Session: Space - Aging Orbiter

Cris Curtis

United Space Alliance – Space Systems Engineering
Orbiter Subsystem Area Manager

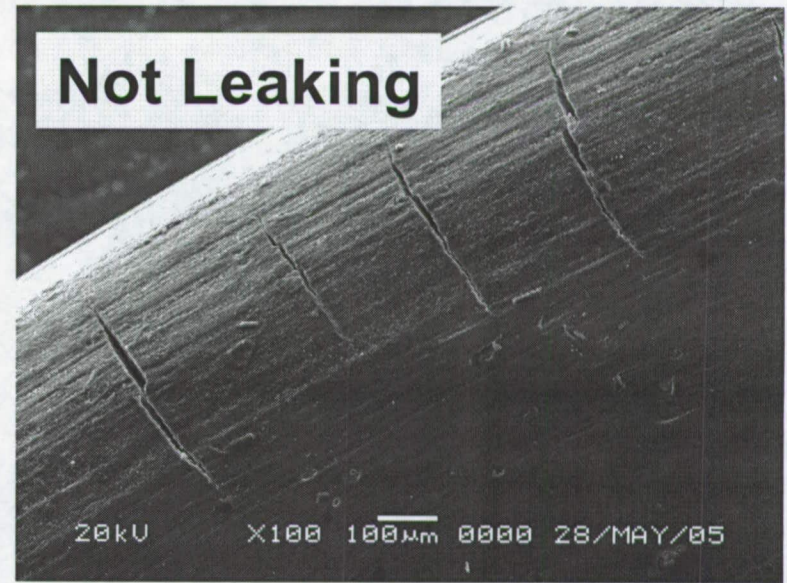
- **Discovery's Return to Flight**
 - **Main Propulsion System, Gaseous Hydrogen Flow Control Valve O-Ring Leak**
- **All Orbiter's O-rings replaced**

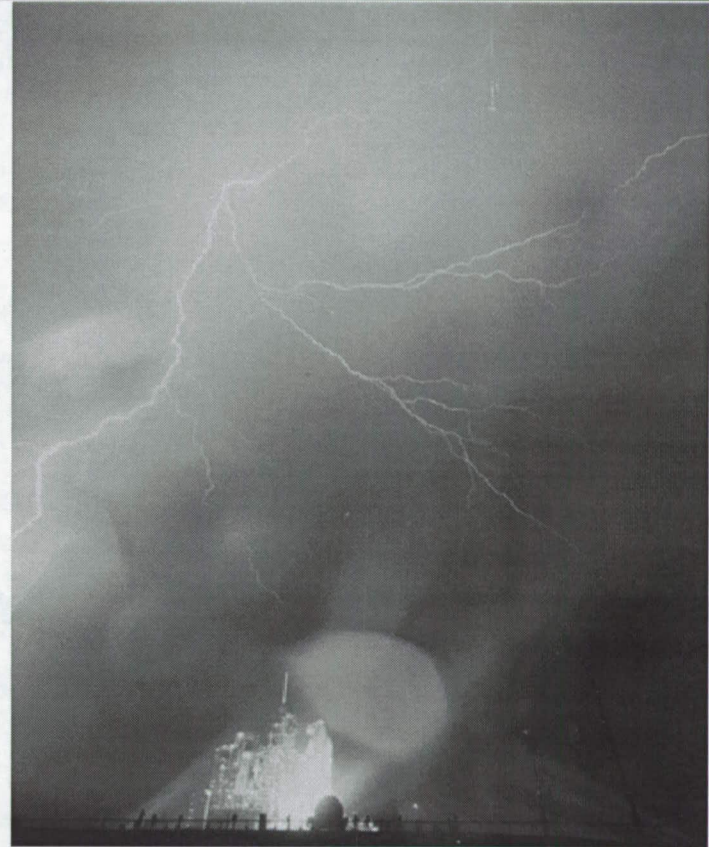
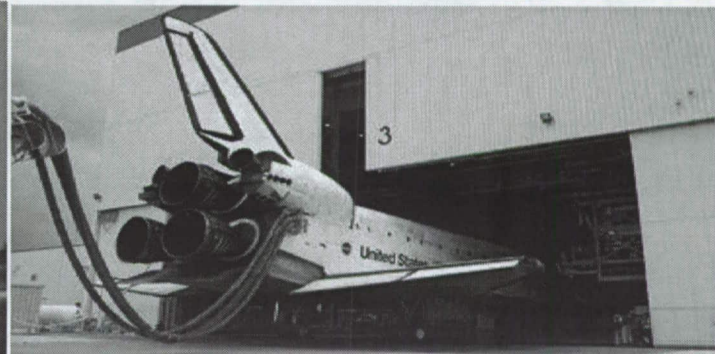
- FCV O-Ring Environment
 - Temperature
 - Pressure
 - Air
 - Ozone
 - Electromagnetic
